Geological factors effecting slope instability in the Virginia Coastal Plain: Observations from the 2018 Nottoway Lane Rotational Landslides, King William County

VA Department of Mines, Minerals, and Energy
Division of Geology and Mineral Resources

April 18, 2019

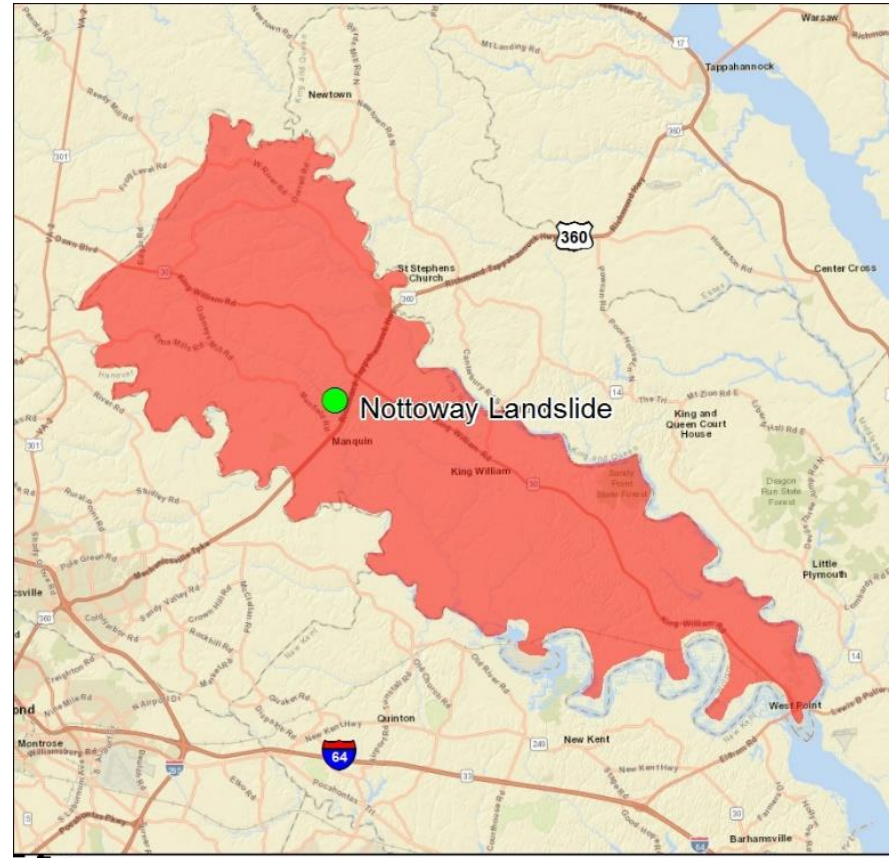
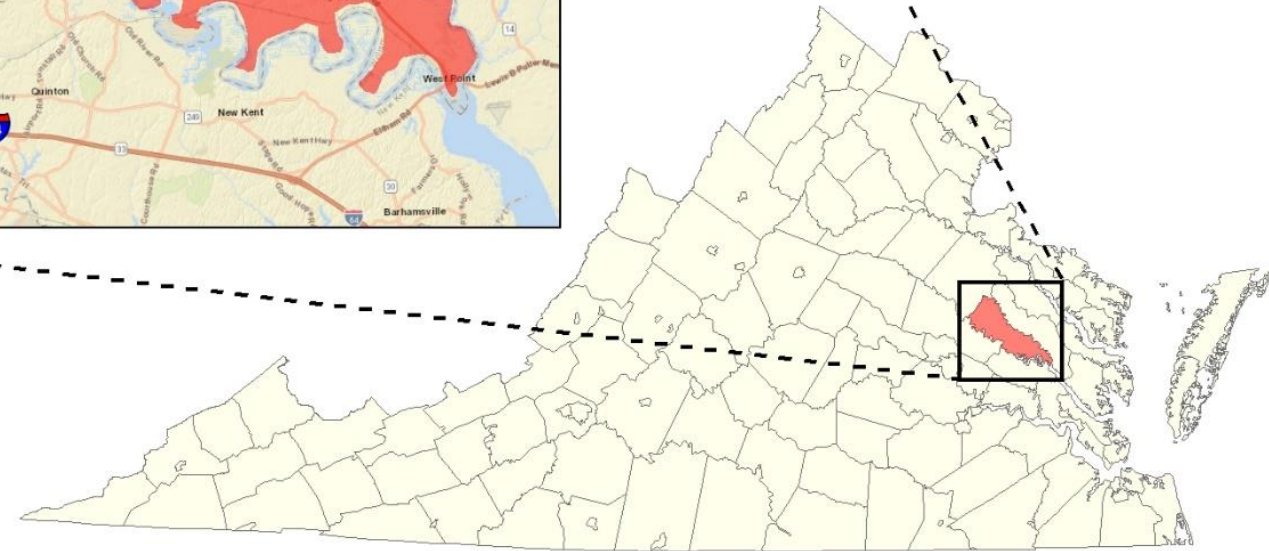
- Based on news reports, the slide occurred in the early morning hours of June 3
 - May/June 2018 had been particularly wet – monthly precipitation totals were 150-300% greater than normal
 - Rain gauge 6-miles to the east received 3.9-inches in 24-hours between June 2-3
 - Several NWS flood watches and warnings issued in the County
- First reported to King William County Building Dept. on June 19

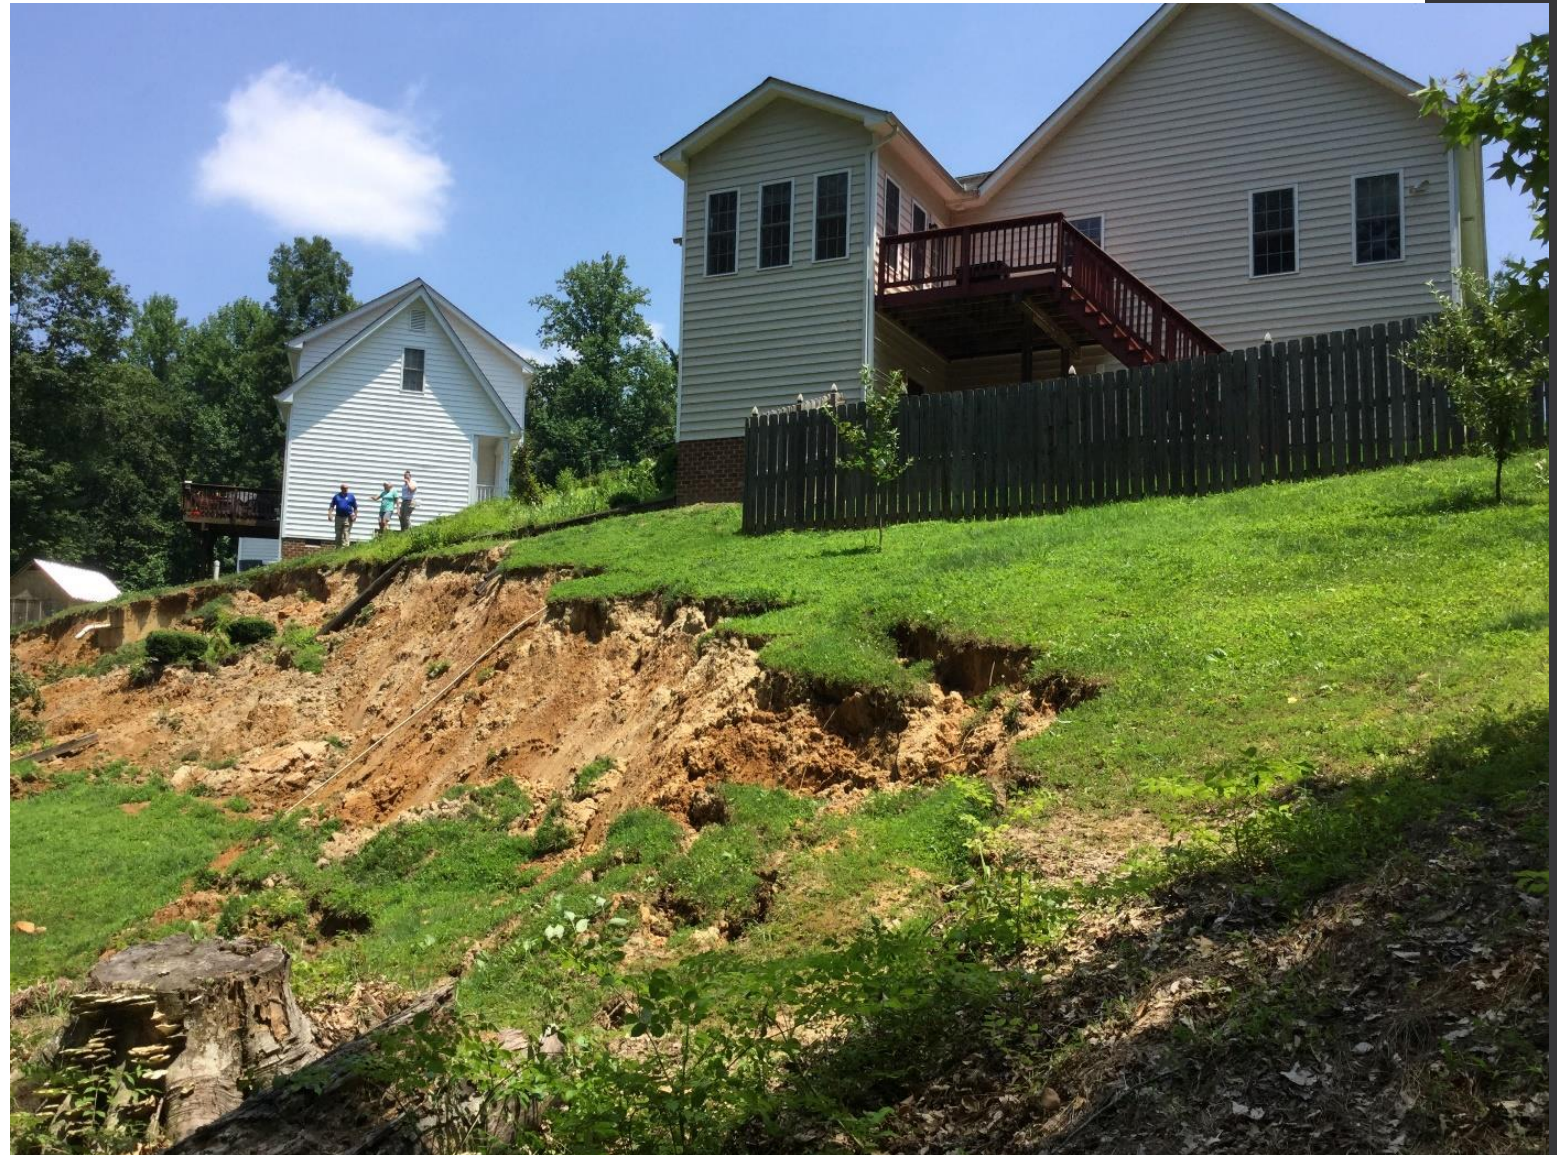
- DGMR was first alerted to the landslide on June 19 as a request for assistance from VDEM and the King William Dept of Emergency Management
- First reported as a sinkhole behind two houses at 360 and 362 Nottoway Lane
- Both homes were condemned on June 19

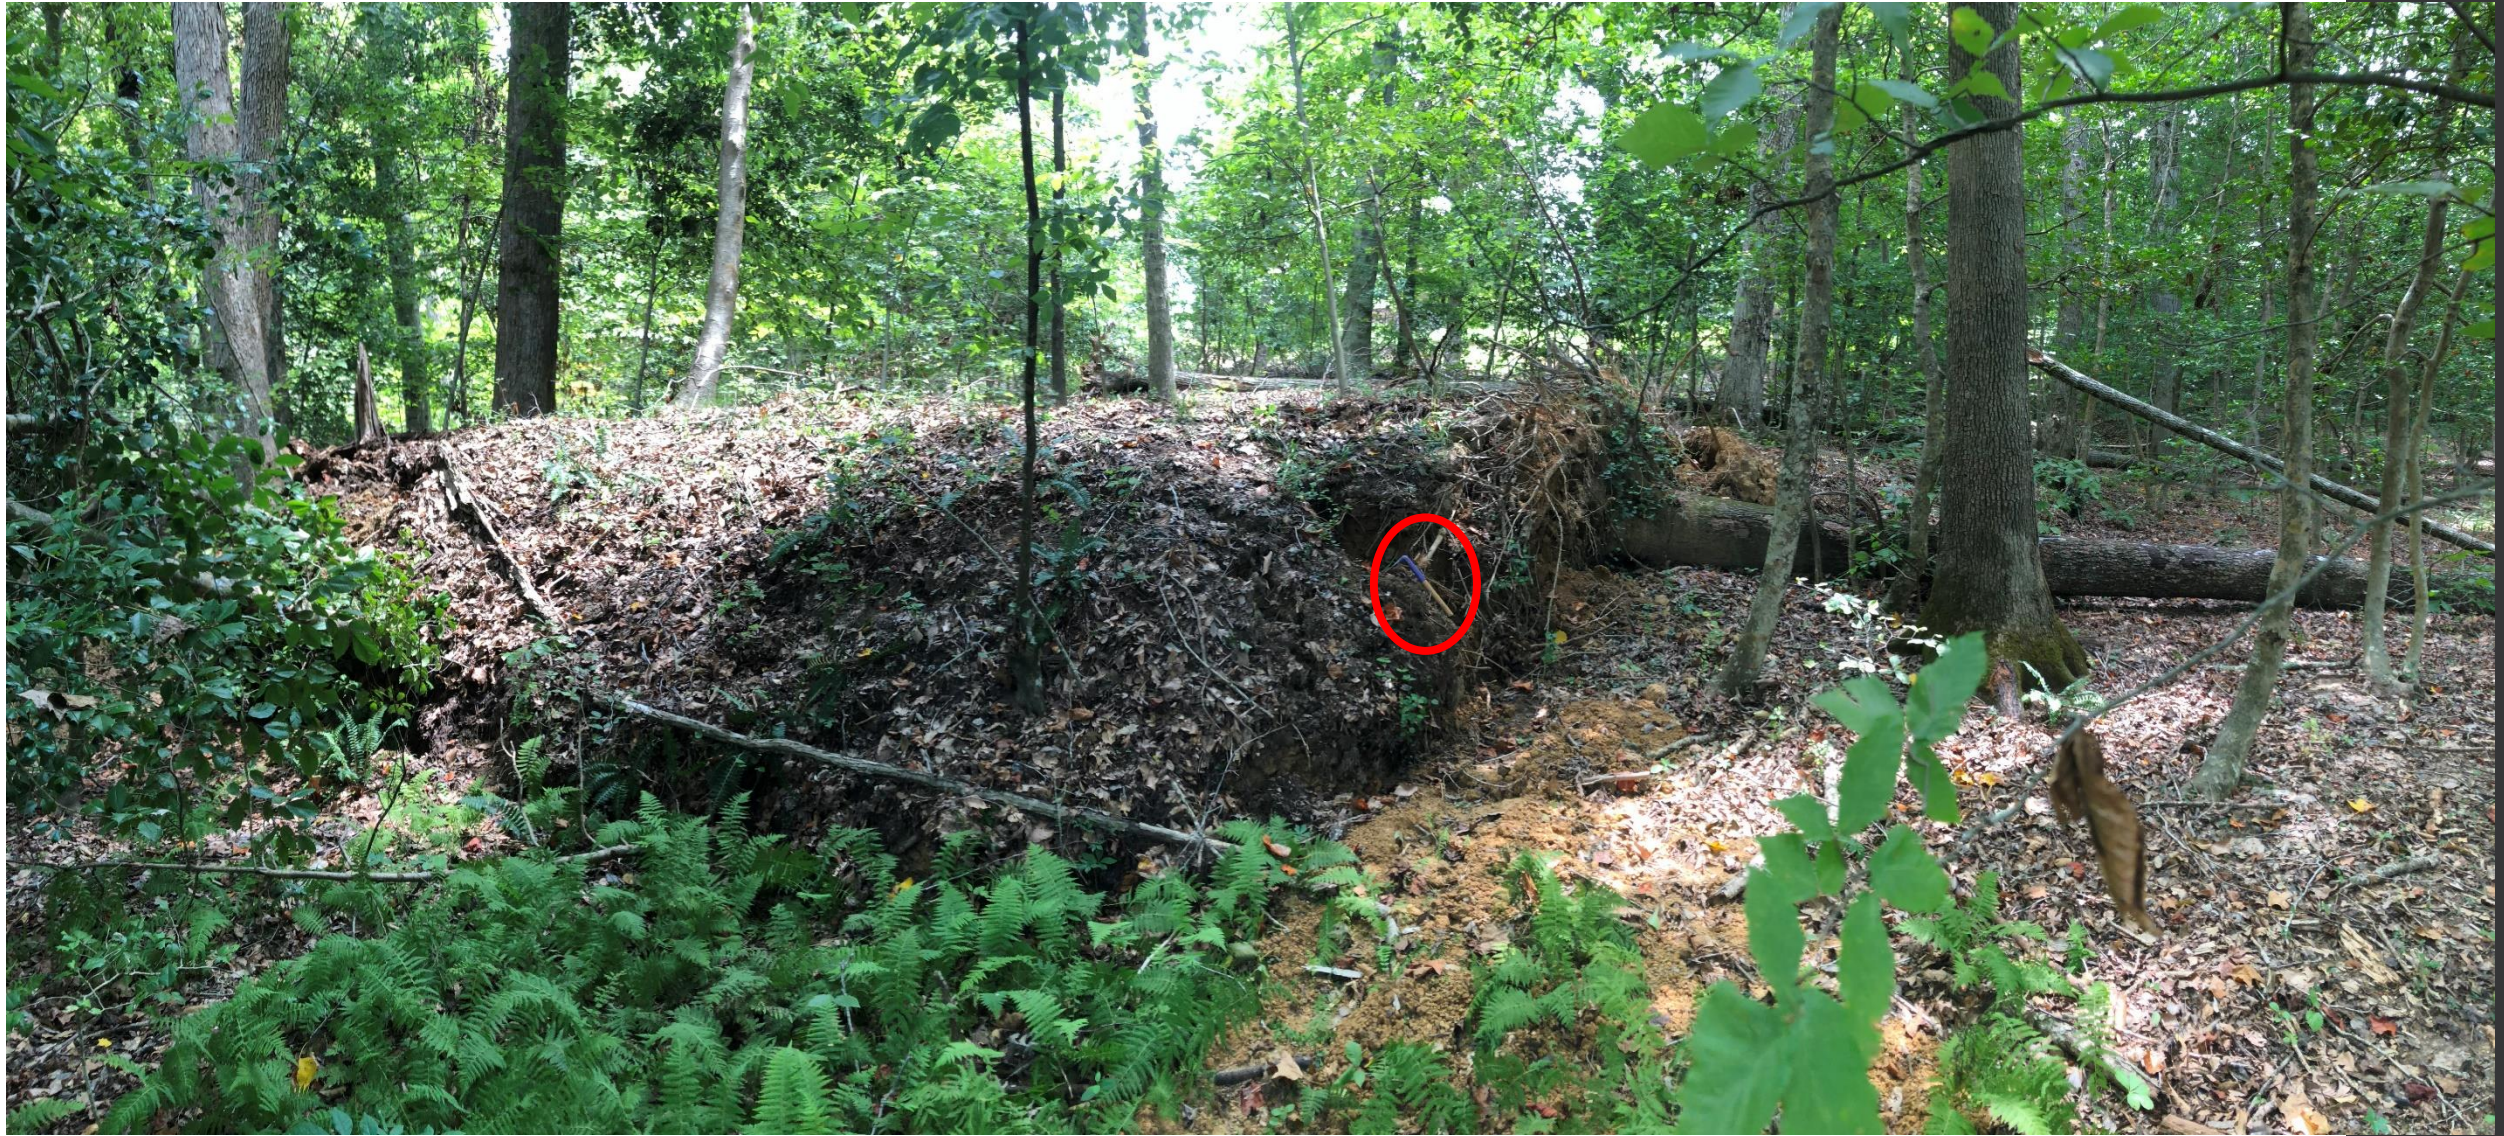
- 6ft high “roll-front” toe that had moved over the original ground surface
- Uprooted and buried trees in landslide debris
- Tension cracks with horizontal and vertical displacement indicated that the landslide was continuing to propagate uphill – dangerously close to 362 Nottoway

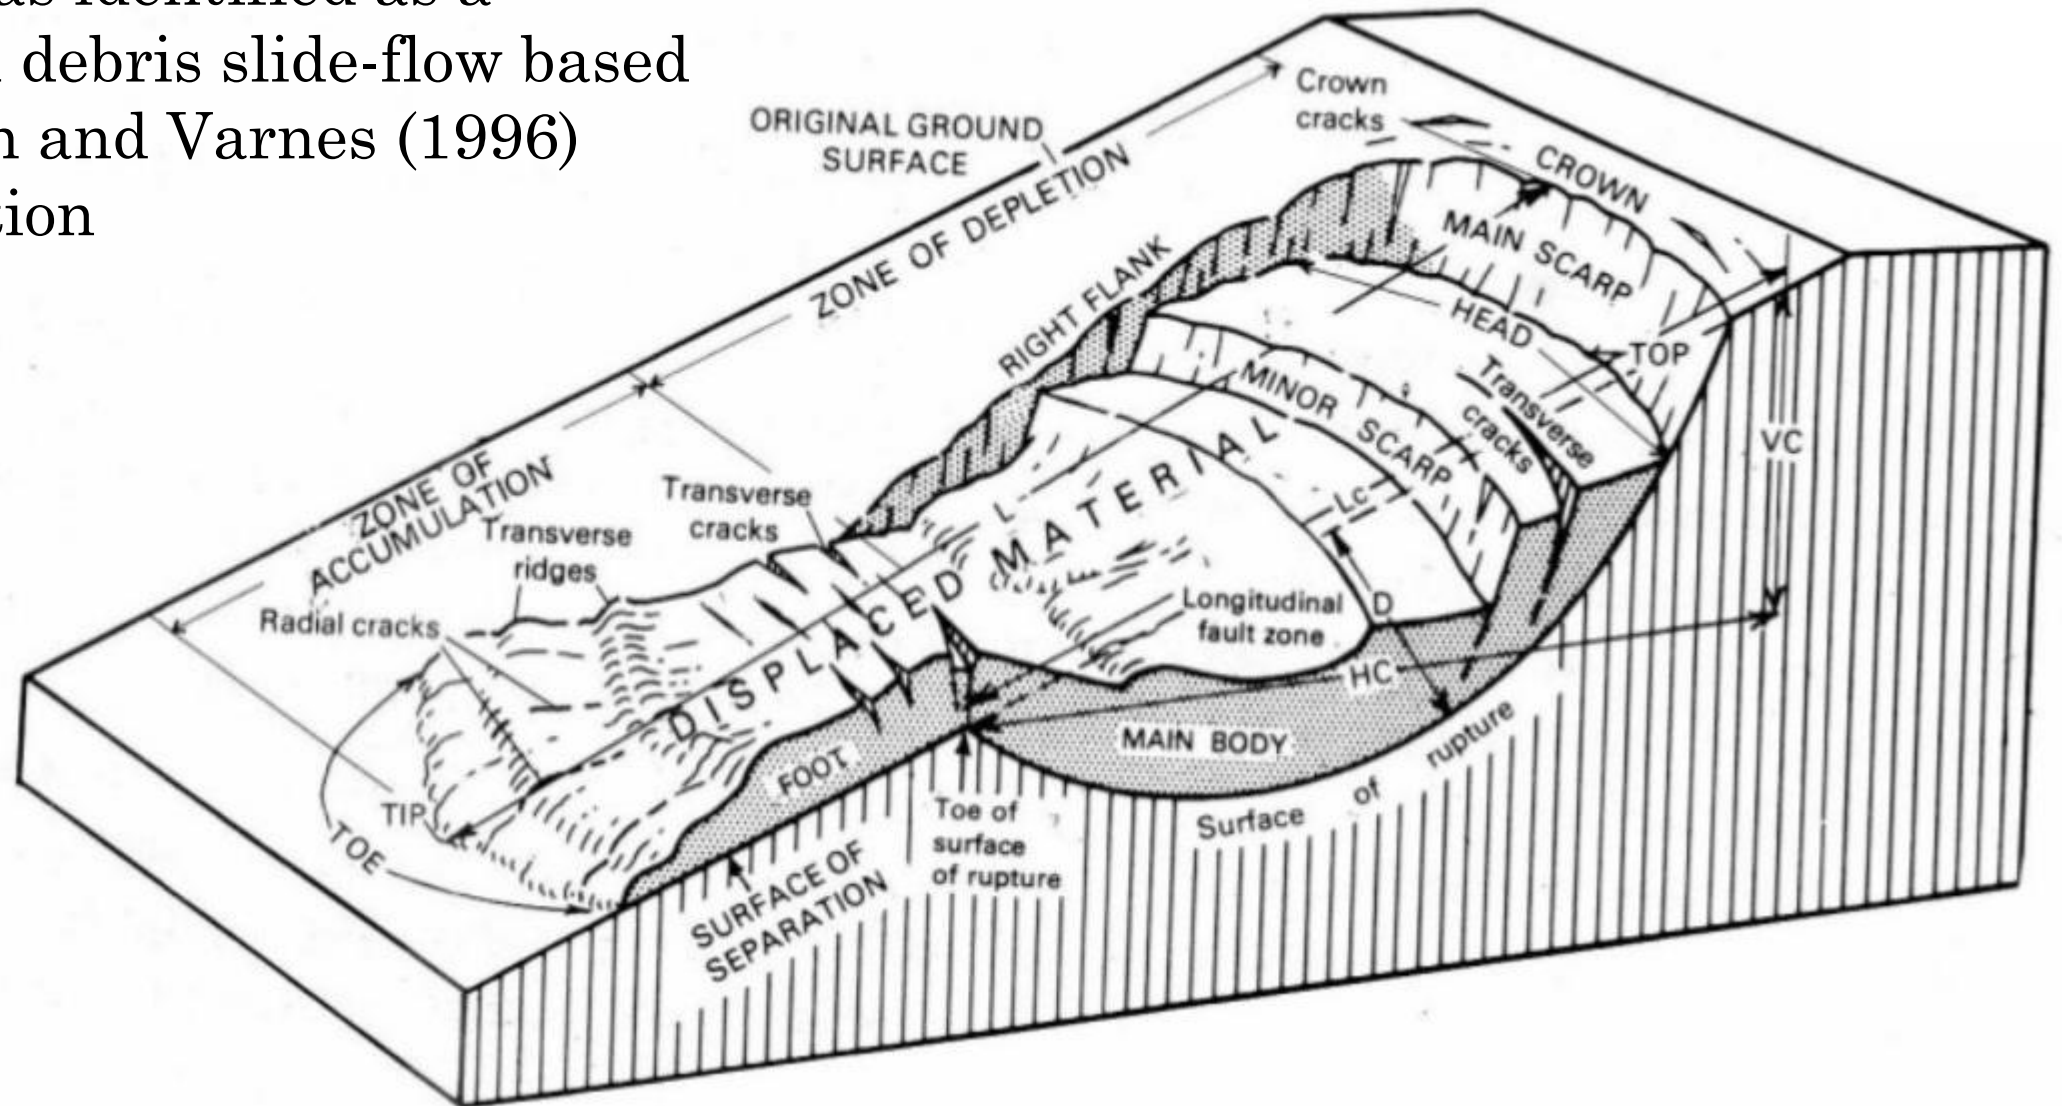
- Based on this evidence, the feature was identified as a rotational debris slide-flow based on Cruden and Varnes (1996) classification

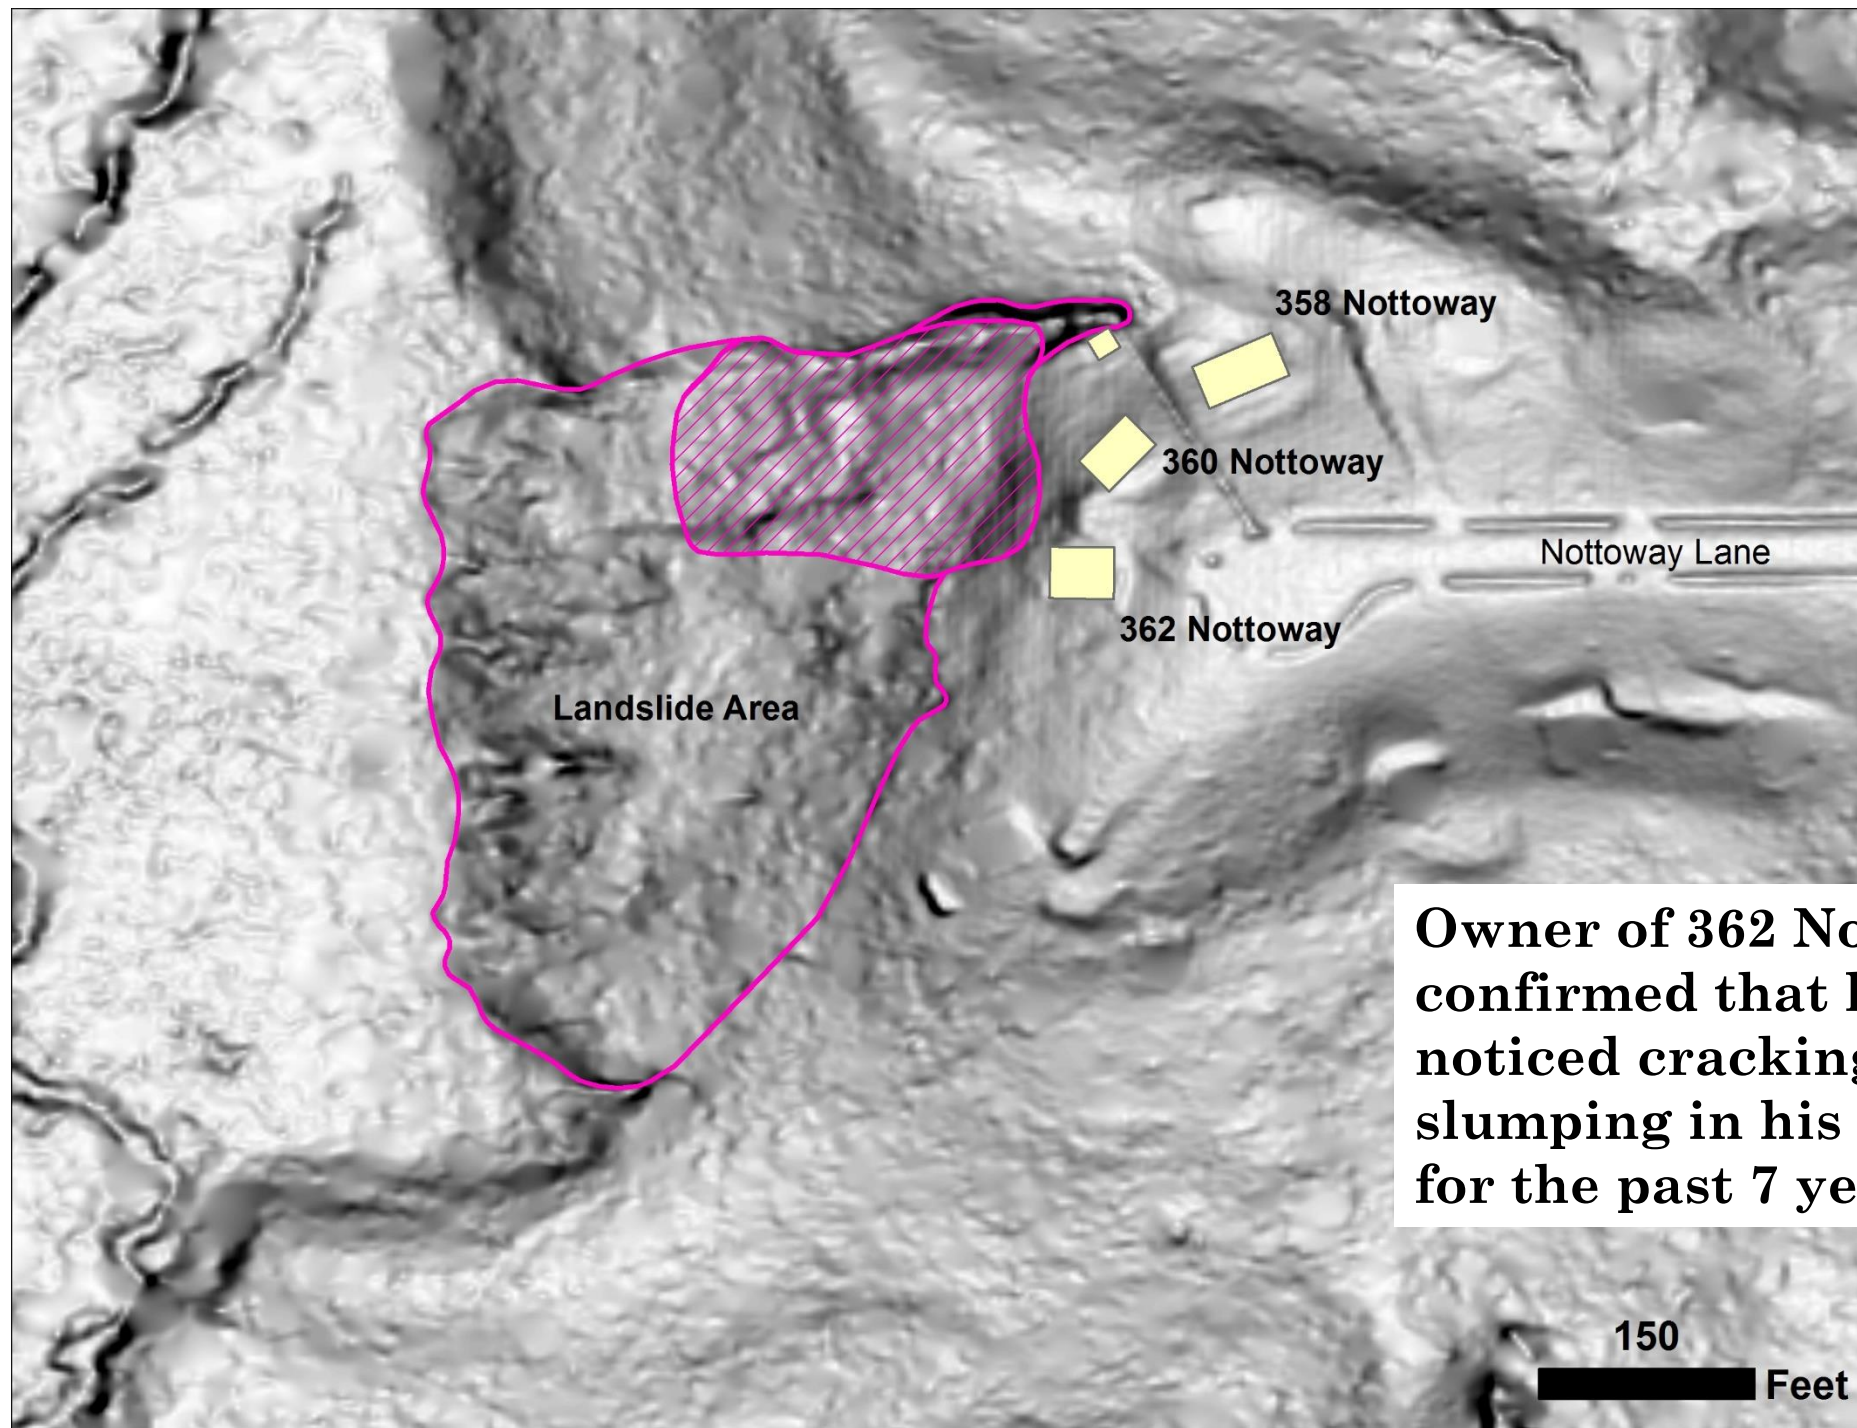
Owner of 362 Nottoway confirmed that he had noticed cracking and slumping in his backyard for the past 7 years.

- Revisited neighborhood July 25:
 - Site A = Debris flow
 - Site B = Debris slide
- Both had significant regrowth in the head scarps → landslides were older than 10 years
- Neither posed a threat to life or property

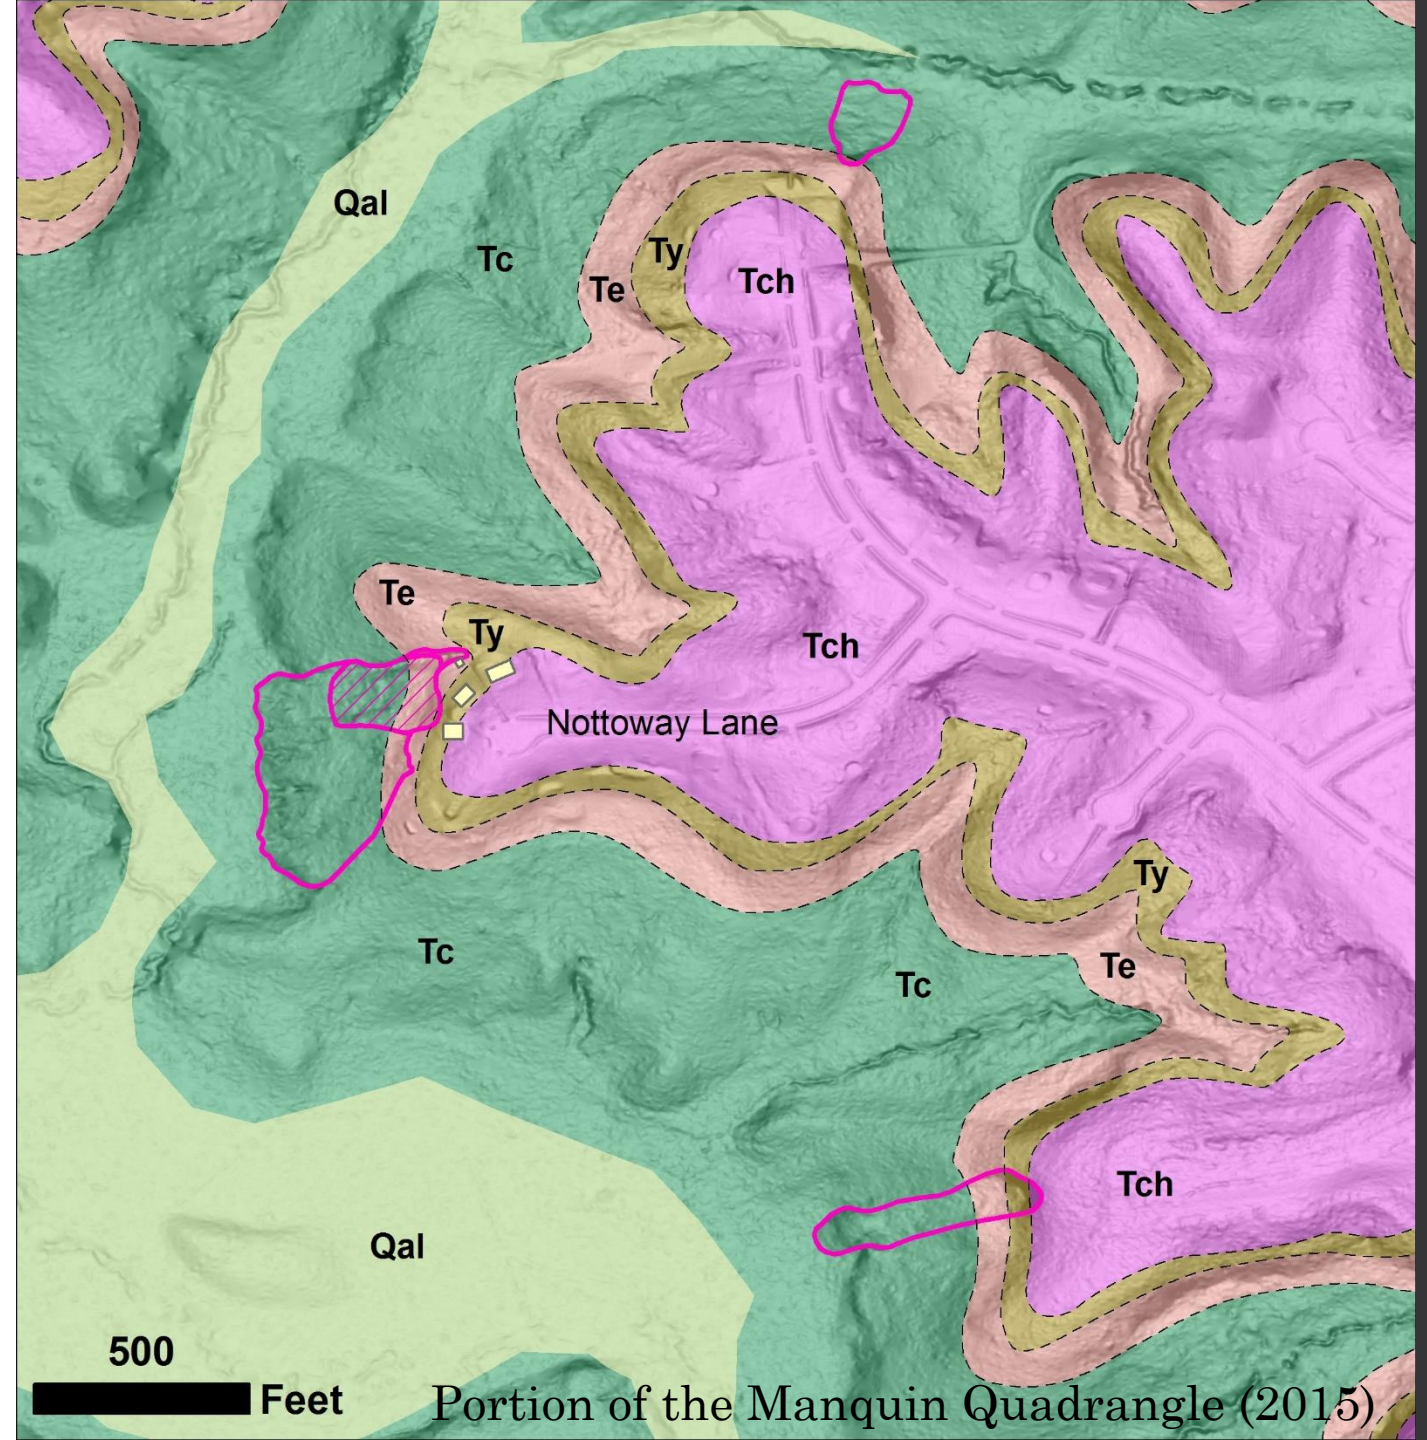
- Stratigraphy of the landslide headscarp examined by DGMR and USGS on August 1
 - Cold Harbor – 0-8.9 ft
 - Yorktown – 8.9-18 ft
 - Eastover – 18 to base of headscarp

- Stratigraphy of the landslide headscarp examined by DGMR and USGS on August 1
 - Cold Harbor – 0-8.9 ft
 - Yorktown – 8.9-18 ft
 - Eastover – 18 to base of headscarp
- Eastover Formation – well-jointed, firm, silty clay that breaks easily along joint faces and fracture surfaces
 - Framboidal pyrite found on fresh surfaces
 - When exposing with hand shovel, groundwater readily flowed from fractures in the clay

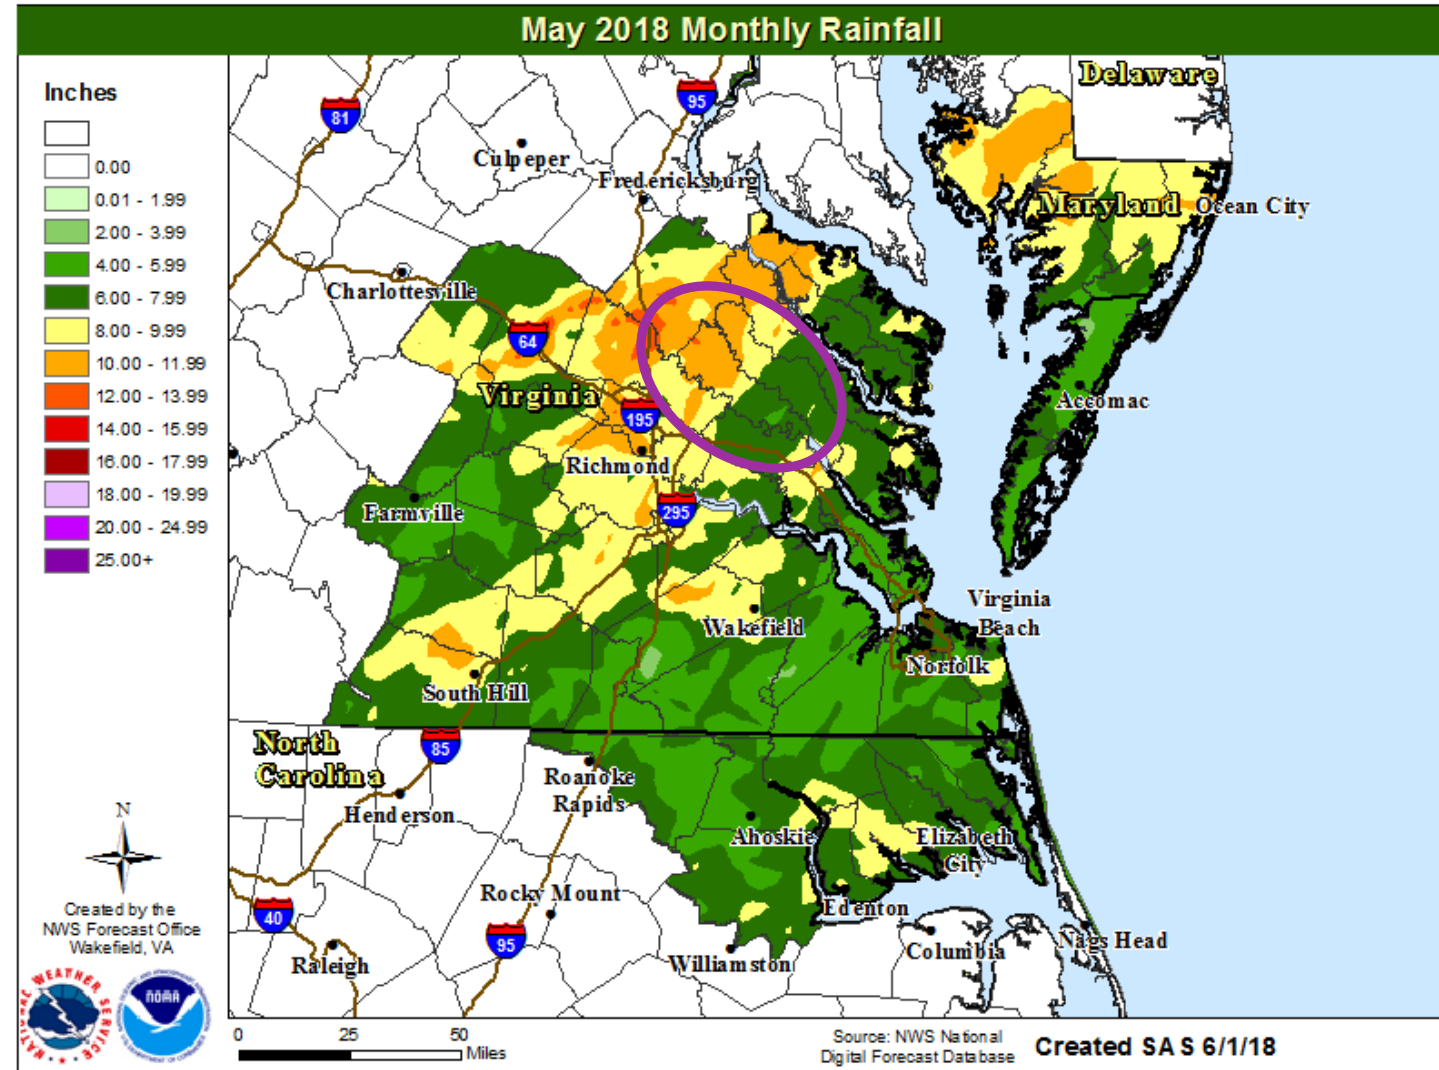
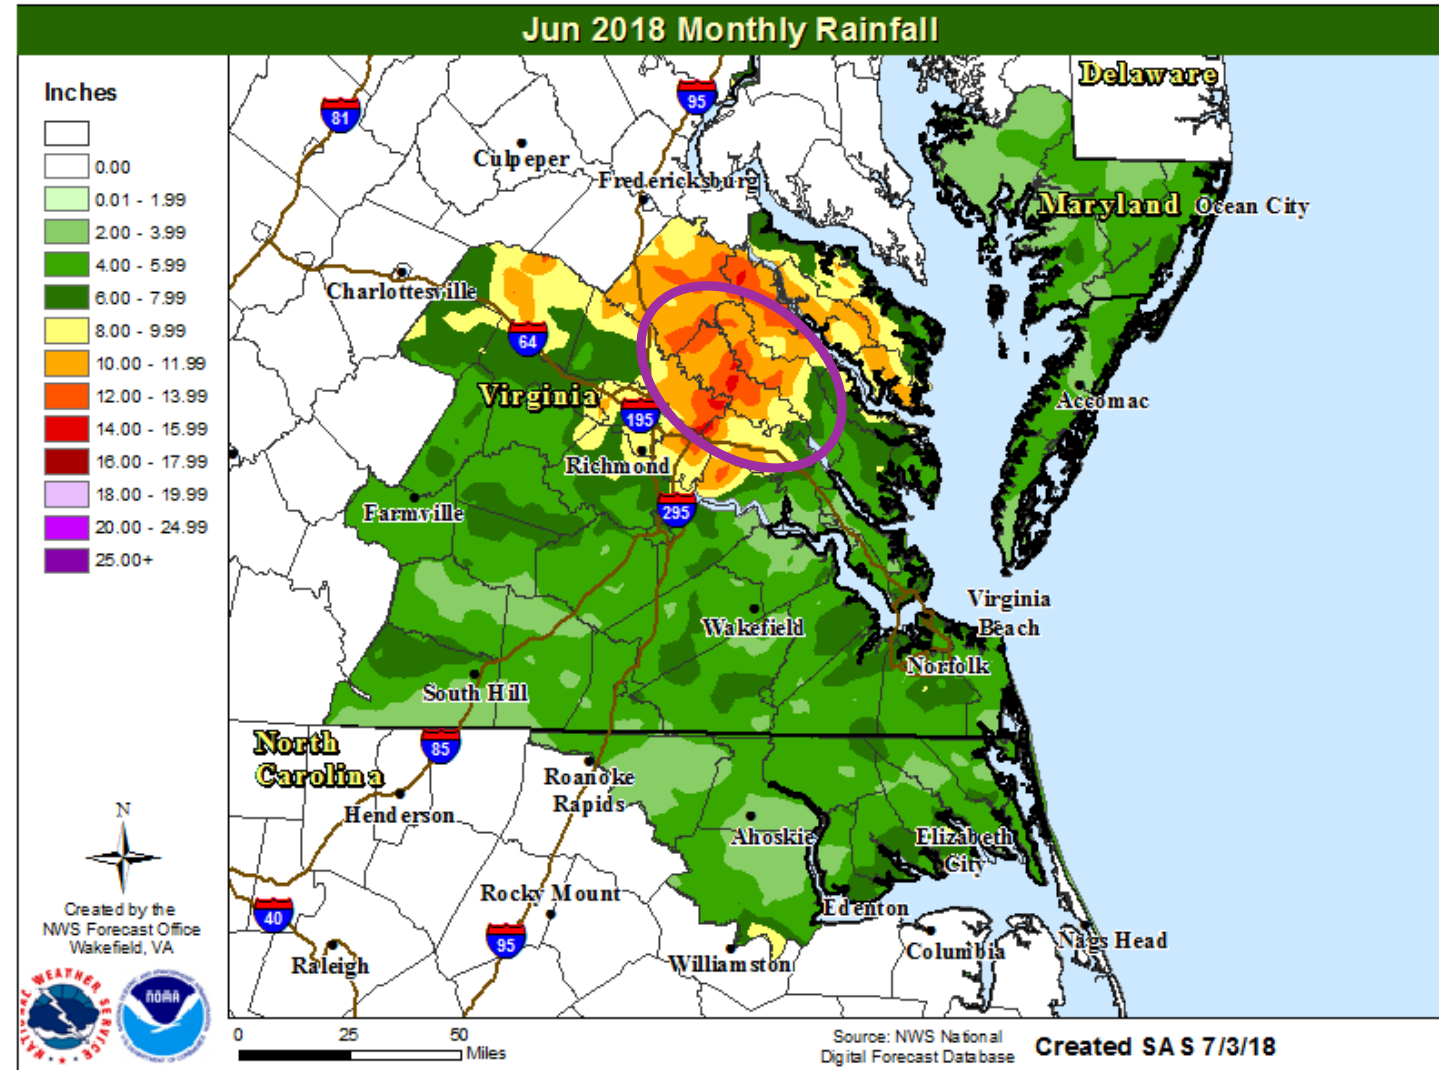
- Precipitation was the likely cause of the Nottoway Landslide
 - May and June 2018 had been particularly wet; monthly precipitation totals 150-300 percent greater than normal

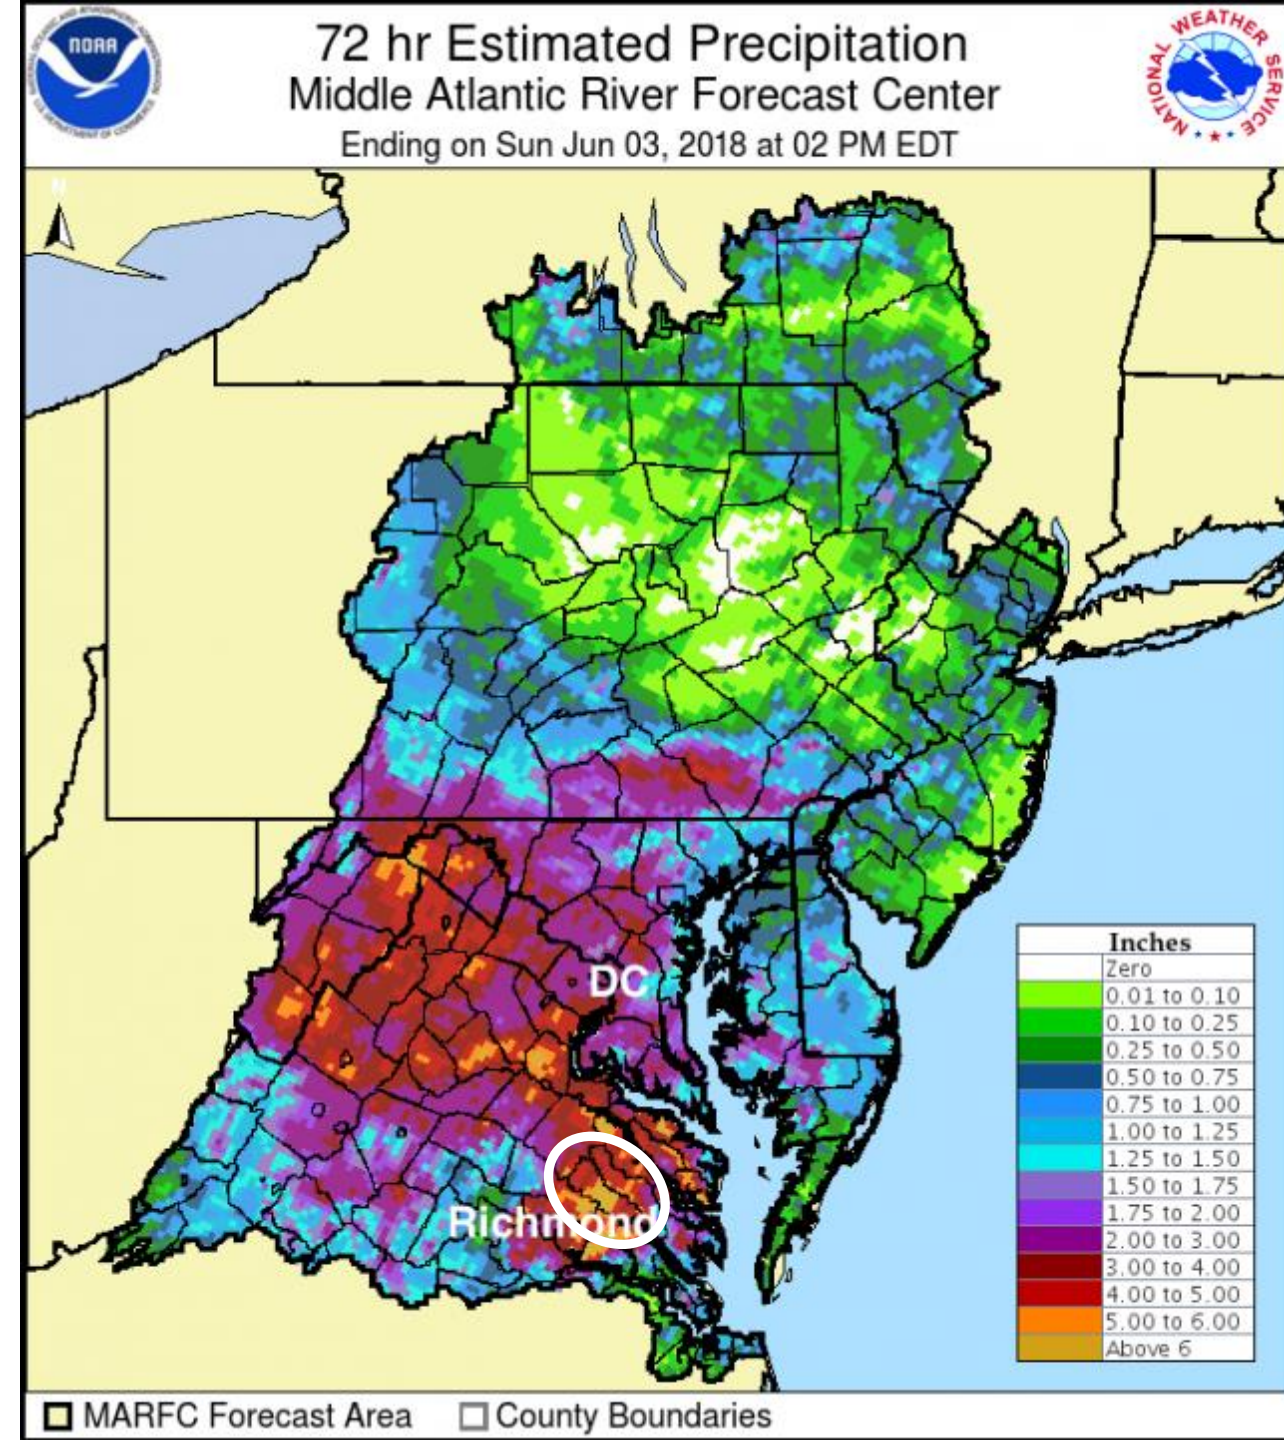
- Precipitation was the likely cause of the Nottoway Landslide
 - May and June 2018 had been particularly wet; monthly precipitation totals 150-300 percent greater than normal
- Between June 2-4, a stationary low-pressure system produced 2-4 inches of rain across Northern and Eastern Virginia
 - Heavy rain early on June 3 (3.9 in 24-hours by the nearest rain gauge) likely triggered the initial failure
- From June 20-22, thunderstorms along a stationary front also produced significant rainfall → triggered additional downslope movement

- Storm water runoff also contributed significantly to the slide and probably accelerated the reactivation of the slope
 - Concrete-lined storm drain between 358 and 360 Nottoway drains into the right-lateral flank of the landslide
 - Driveways between 360-362 Nottoway provided conduits for rainwater

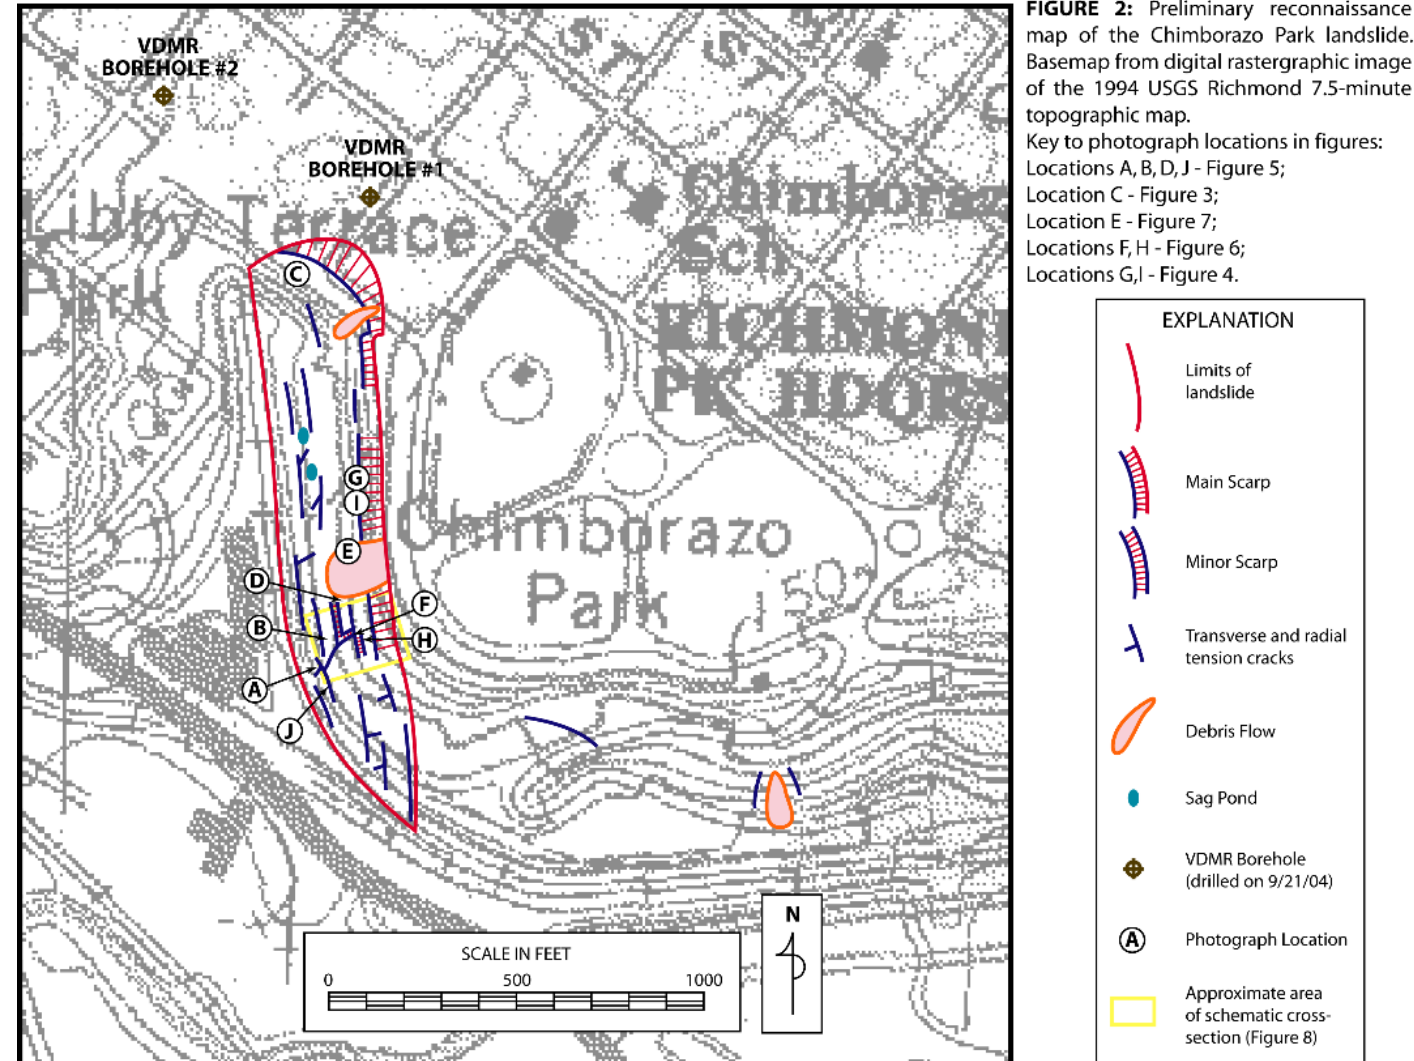
- Rupture surface of the Nottoway landslide probably occurred in the clay-rich Eastover along a fracture surface, or at the contact between the Eastover and the Yorktown
- Similar to the 2004 Chimborazo Hill landslide in Richmond
 - Rotational-translational debris slide
 - Rupture surface within the Eastover with numerous joints and fracture sets
 - West-facing slope
